building inspection service, inc.

CONFIDENTIAL INSPECTION REPORT

Style of Building:

Single Family

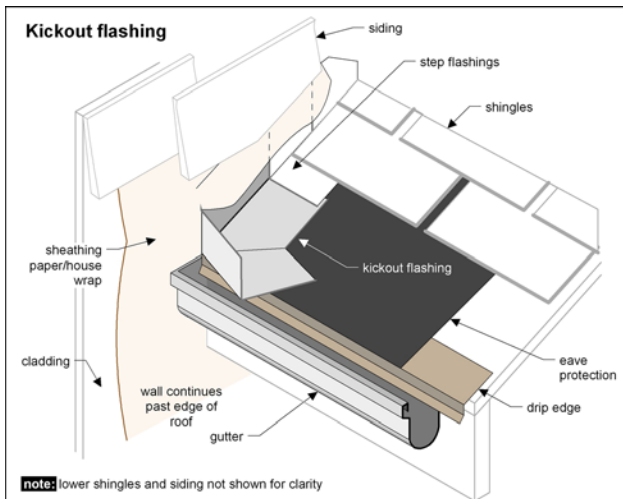
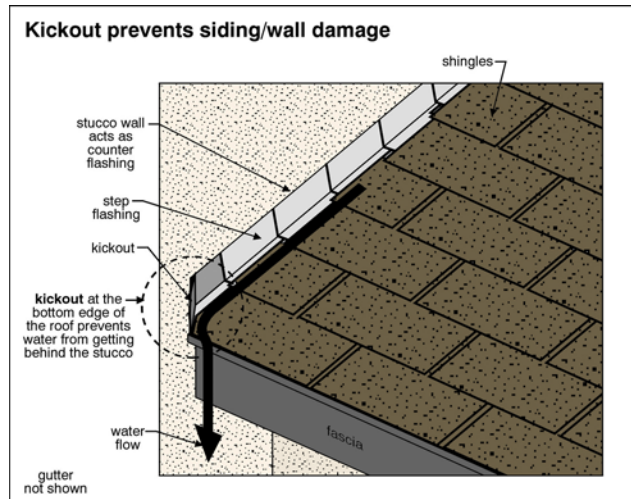
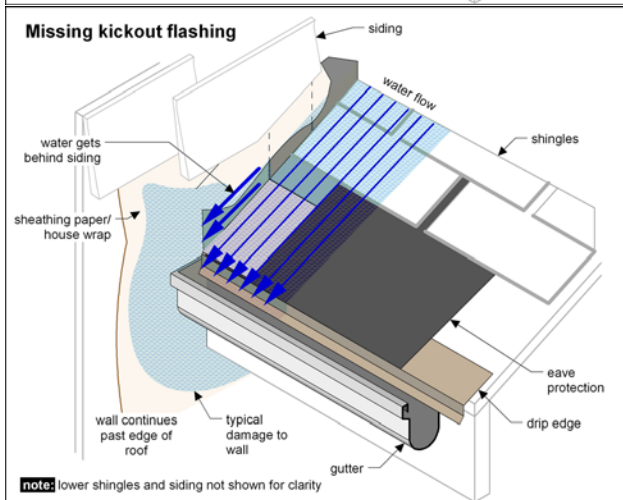
There were no kickout / diverters installed at the roof / wall intersections at the right and left sides of the family room chimney. Accumulating water runoff should be directed out and away from the building. Roof-to-wall flashing areas require a kickout / diverter at the bottom termination of the flashing to insure water is directed to the outside of the wall surfaces. This will help to prevent internal as well as external wall damage from occurring. The installation of kickout / diverters will be required. Obtaining cost estimates for their installation prior to closing is recommended. See photos 19 and 20 and the illustrations below.

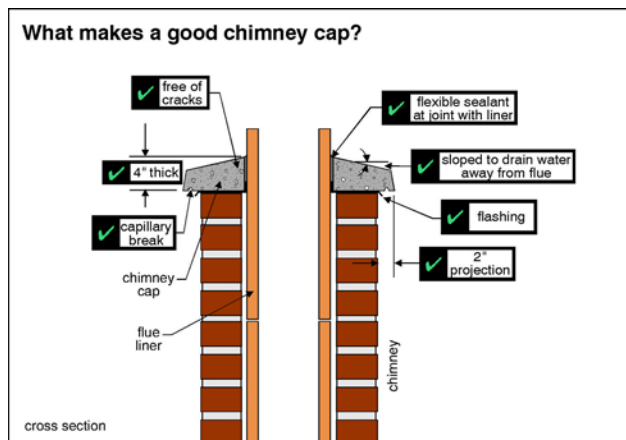
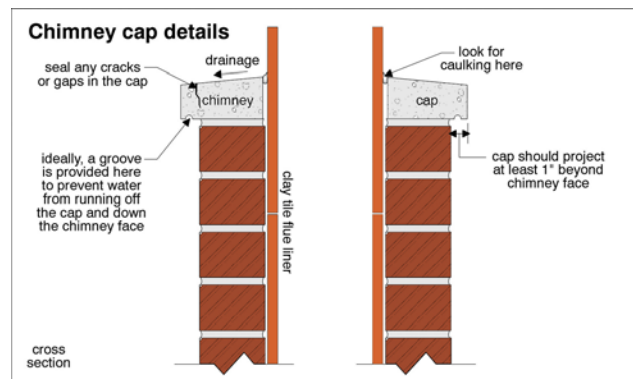
The chimney crown/wash was cracked, loose and deteriorated on the rear family room chimney with its replacement required to prevent water damage to the interior of the building and to the chimney. See the illustrations below.

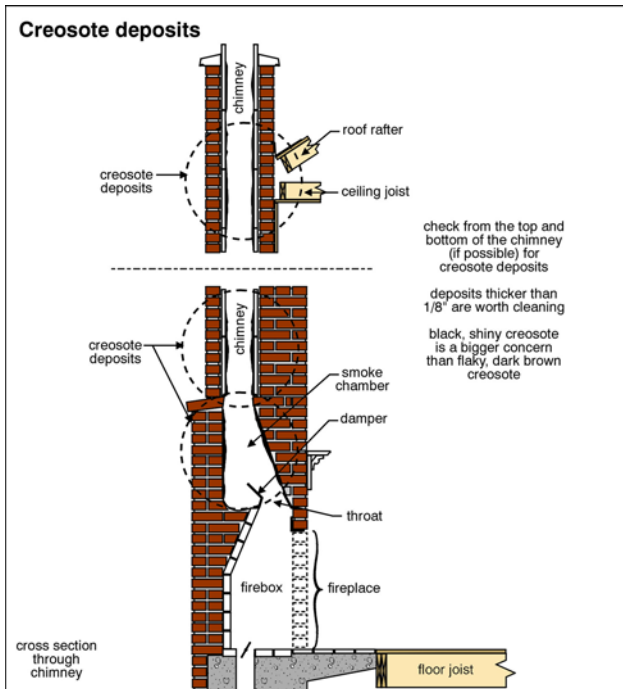
A creosote build up was noted inside the interior of the chimney. This is a fire safety concern. It is required that the creosote be cleaned by a licensed chimney sweep prior to using the fireplace and thereafter depending upon use, to prevent chimney fires from occurring. See the illustration below.

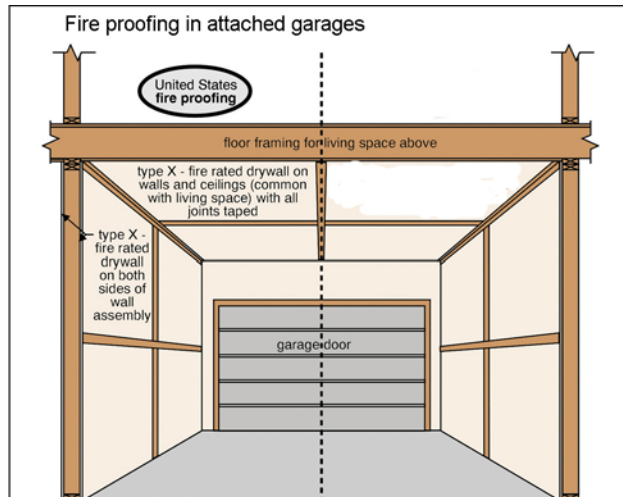
Openings in the garage walls and ceiling were noted. This is a fire safety concern. Covering of the openings with 1/2-inch fire 'X' drywall is required by current building practices for fire safety reasons. See photos 47 and 48 and the illustration below.

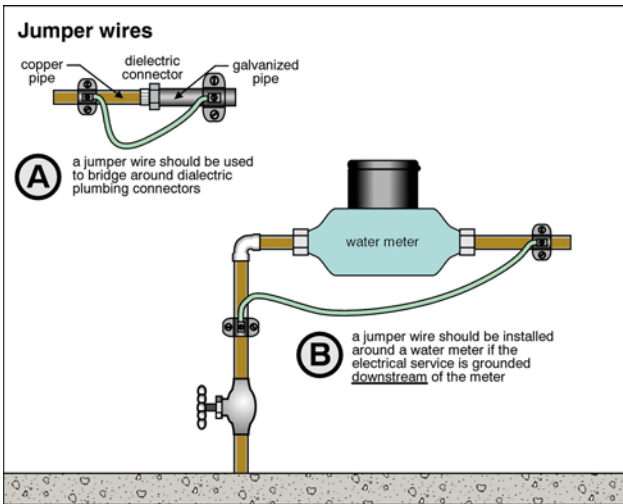
There was no water meter shunt wire/cable installed. The installation of a water meter shunt wire/cable is recommended/required as per the National Electrical code. See the illustration below.

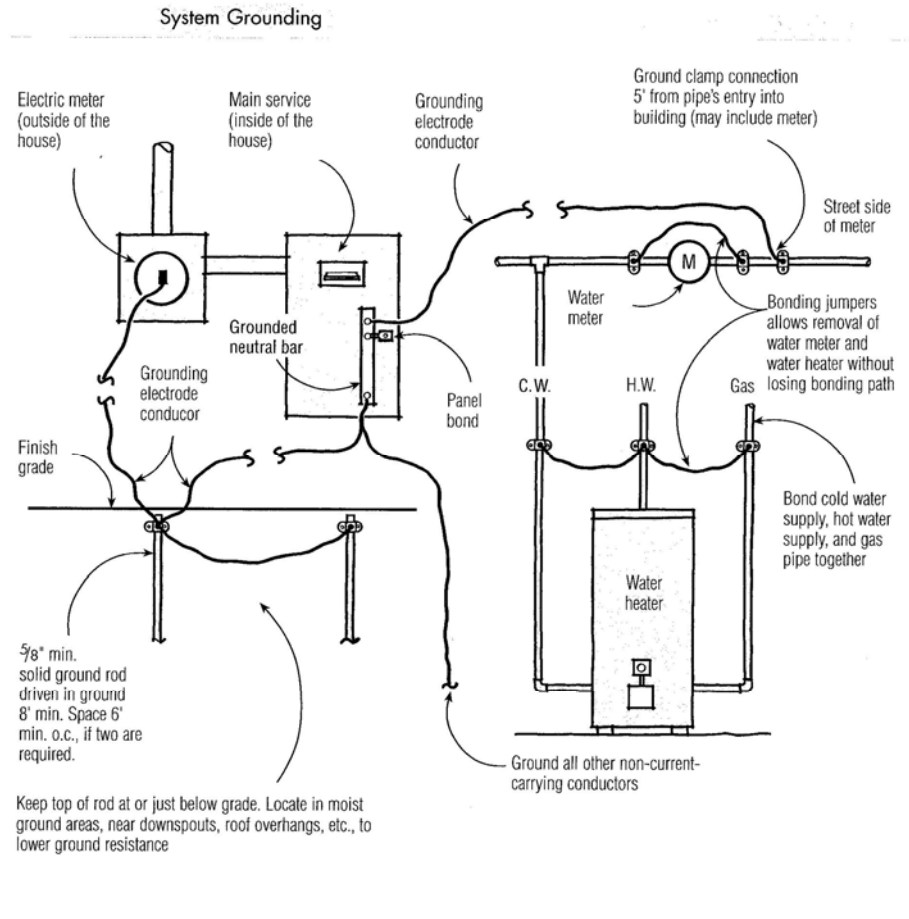
There was no bonding cable installed on the water heaters' water supply piping. Its installation is required by current electrical standards. See the illustration below.

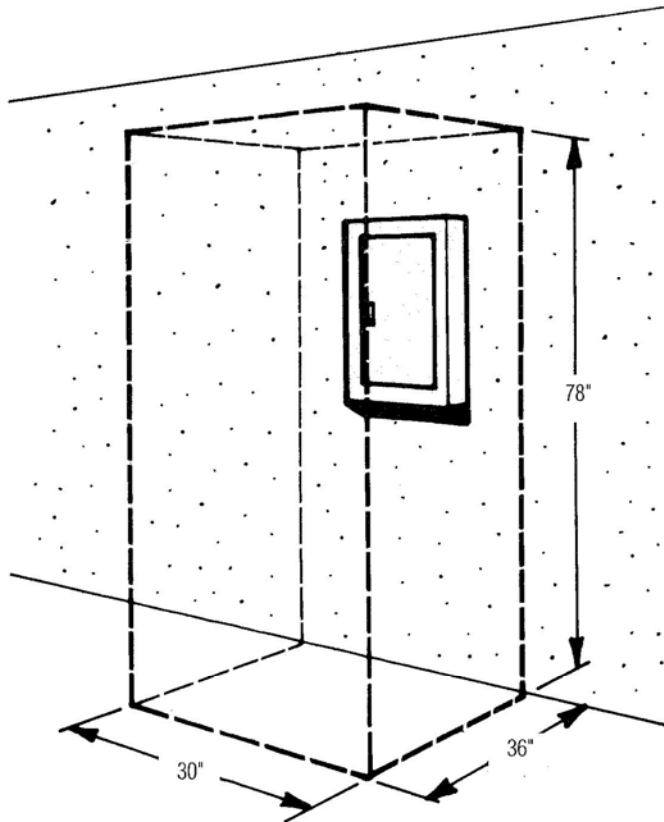
Clearances at the Panel

The distance on the sides and/or in front of the electrical panel box was inadequate with repairs required. Contacting a licensed electrician for cost estimates on the required repairs will be required prior to closing. Standard accepted electrical wiring practices require a clear work space with a 30-inch wide clearance required on the sides of the panel box and a 36-inch deep clearance required in front of a panel box and there must be 80-inches of height clearance in front of the breaker panel box or meter. See photos 55 and 56 and the illustration below.

For a 200-amp or smaller panel, code requires 3 ft. of clear space in front of the panel, 30 in. wide, and extending from the floor to a height of 6 ft. 6 in. No pipes or ducts may cross this space. In addition, the door of the panel must be able to open at least 90 degrees.

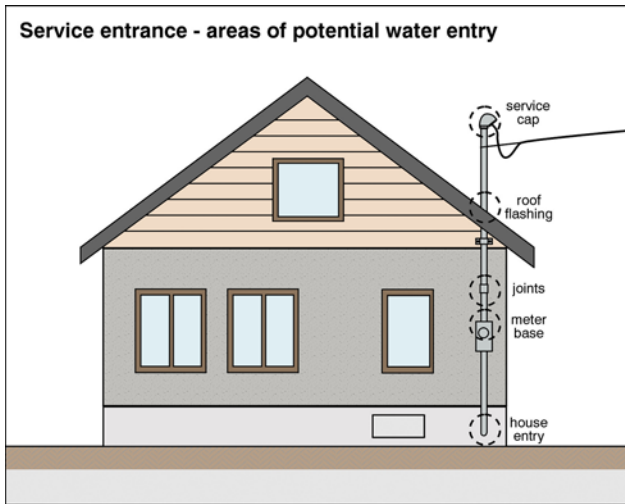
Evidence of water entry inside the panel box was noted. This may be from water entering through the meter box or the weather head. Sealing of the meter box and weather head will be required. It is also required that the circuit breakers be checked by a licensed electrician to insure their safe operational condition and to make any required repairs or replacements. A letter to this effect should be obtained from the licensed electrician prior to closing. See photo 79 and the illustration below.

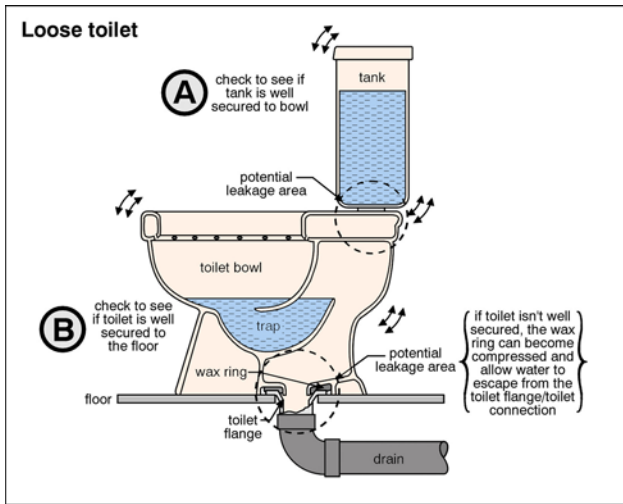
The toilet was loose from the floor. This problem could be as simple as tightening the toilet bolts or replacing the wax seal or it could be a rotted floor below the toilet. A further inspection and repairs by a licensed plumber will be required to prevent leaks from occurring. See the illustration below.

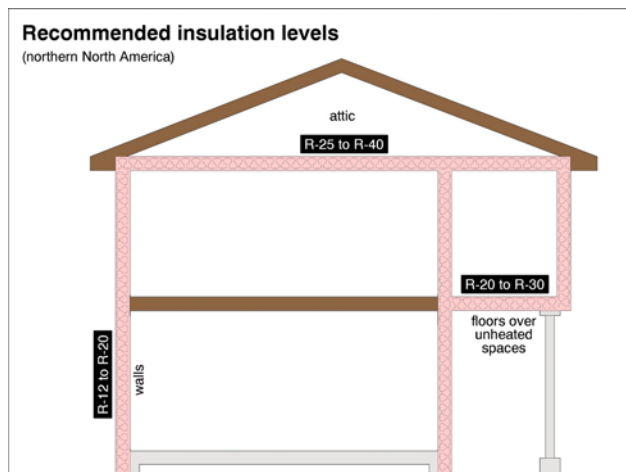
There was 6.5 inches of fiberglass insulation visible in the attic area at the time of the inspection.

The installation of an additional 6-inches to 8-inches of unfaced fiberglass insulation is recommended to reduce energy consumption and help to attain an R-30 rating in the attic area. See the illustration below.
